Manhole Inspection Summary

Manhole # S15GG1026MH

Insp Date: **3/1/07 9:16 AM**

Location Address: **2409 OSWEGO AVE**

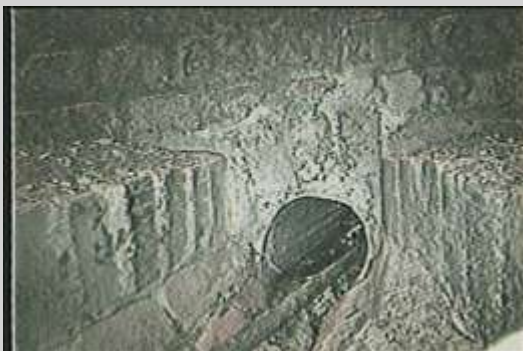
6 in. Circular Gravity Sewer Pipe In @ 4 O'Clock

Rod and Bar (Angled)

Pipe Material: **Clay** ☐ Pipe Lined

Infiltration: **None** Pipe Seal Cond: **Unknown**
